THESIS

ANALYSIS OF SYMMETRIC REINFORCEMENT OF
QUASI-ISOTROPIC GRAPHITE-EPOXY PLATES
WITH A CIRCULAR CUTOUT UNDER UNIAXIAL
TENSILE LOADING

David H. Pickett and Patrick D. Sullivan

December 1983

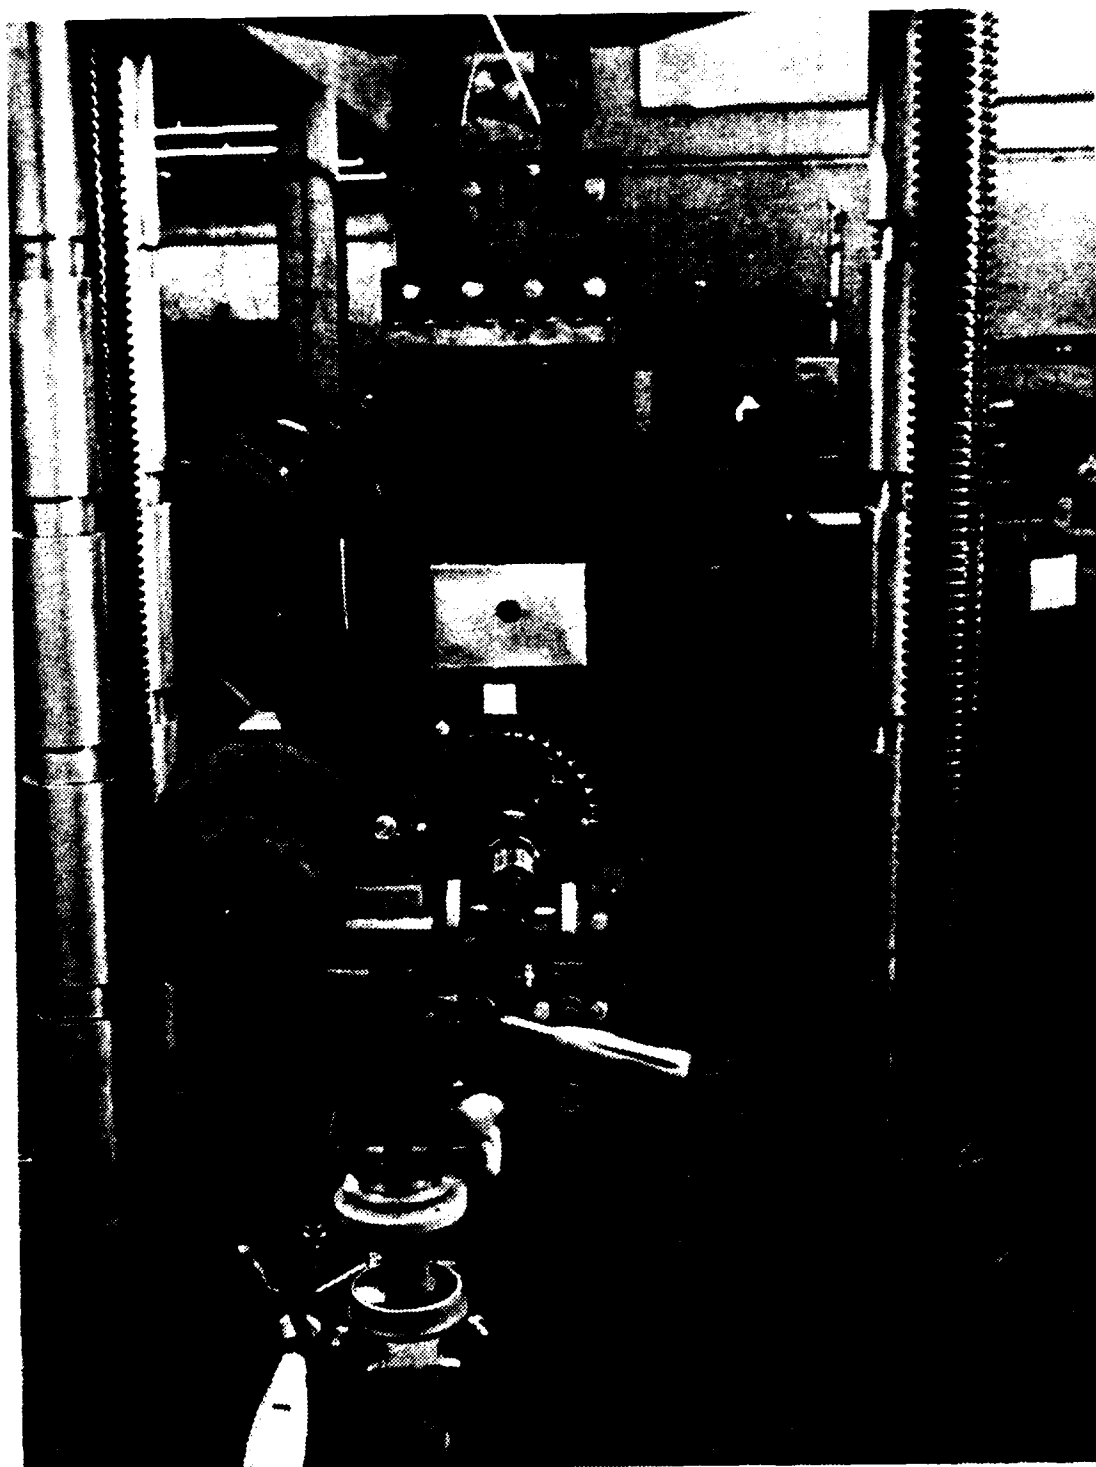
Figure 4.4 Photoelastic Reflection Polariscope.

In order to separate the principal strains, an Oblique Incidence Adapter, Model 033, was used. The Oblique Incidence Adapter attached directly to the Basic Analyzer. With the two measurements obtained (normal and oblique incidence) and the two unknown principal strains, the equations can be solved for principal strains as is detailed in Reference 24.
